PROJECT SUMMARY

With the recent announcement by the Diocese of Manchester stating it will be moving forward with a plan to repair and renovate St. Joseph Church in Laconia for use as a chapel and columbarium (a structure for the reposition of funeral urns within niches), the following outlines the necessary repairs needed to St. Joseph.

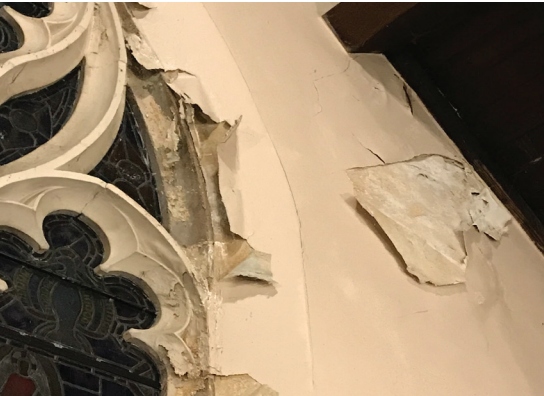
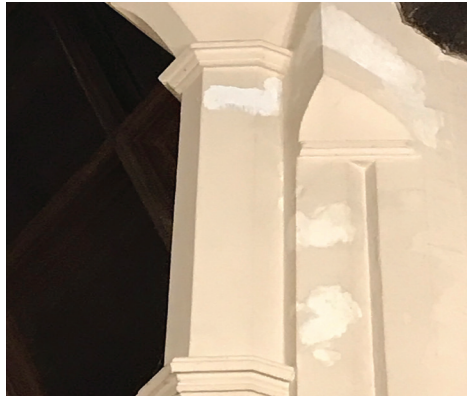
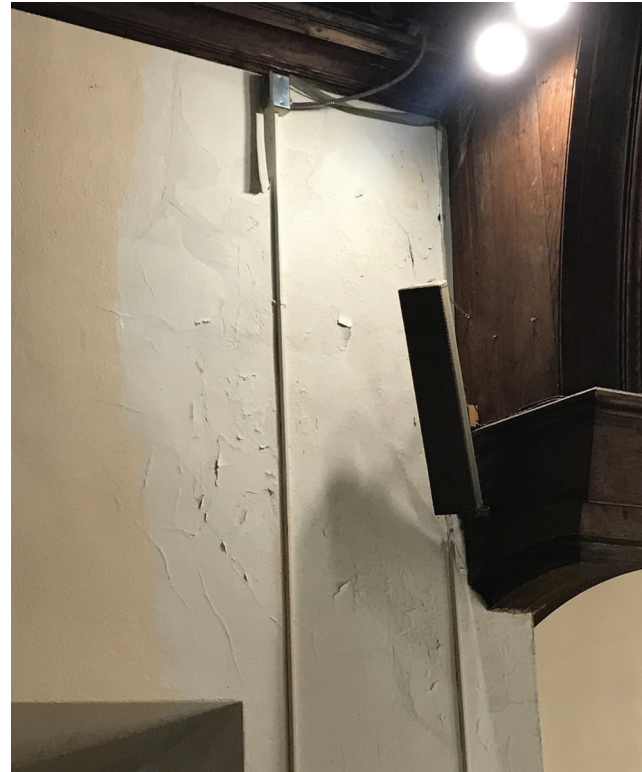
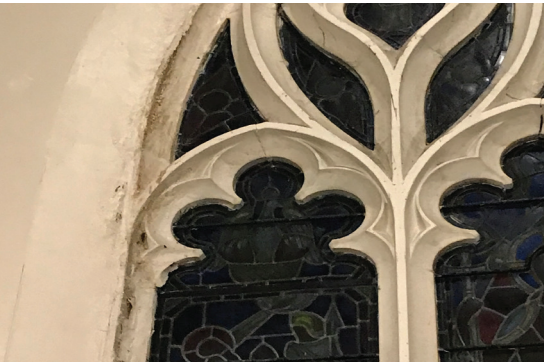
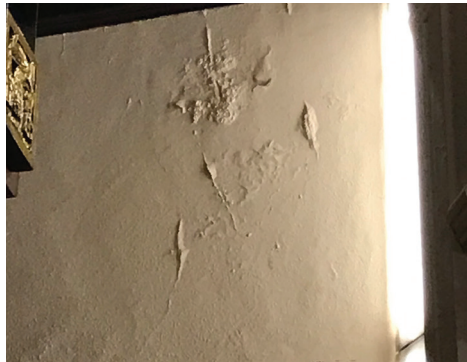
Interior Church Restoration \$1,274,747

- Remediation of mold in narthex, nave, sanctuary and choir loft

- Narthex, sanctuary and nave plaster restoration and painting
- Church ceiling cleaning and light refinishing
- Altar floor tile refinishing and installing protective sealer
- Nave floor – installing commercial VCT tiles
- Repair and refinish pews to be found in the chapel

- Remove excess pews
- Demolition (concrete floor in mechanical room)
- Water mitigation and new concrete slab
- Glass wall partition at chapel/columbarium
- Mechanical and electrical systems upgrades

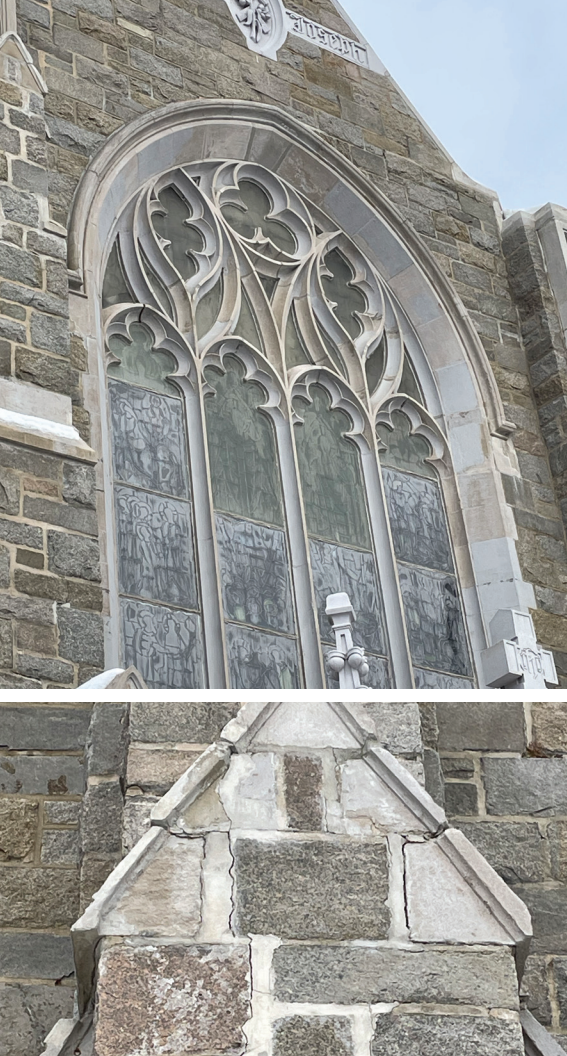
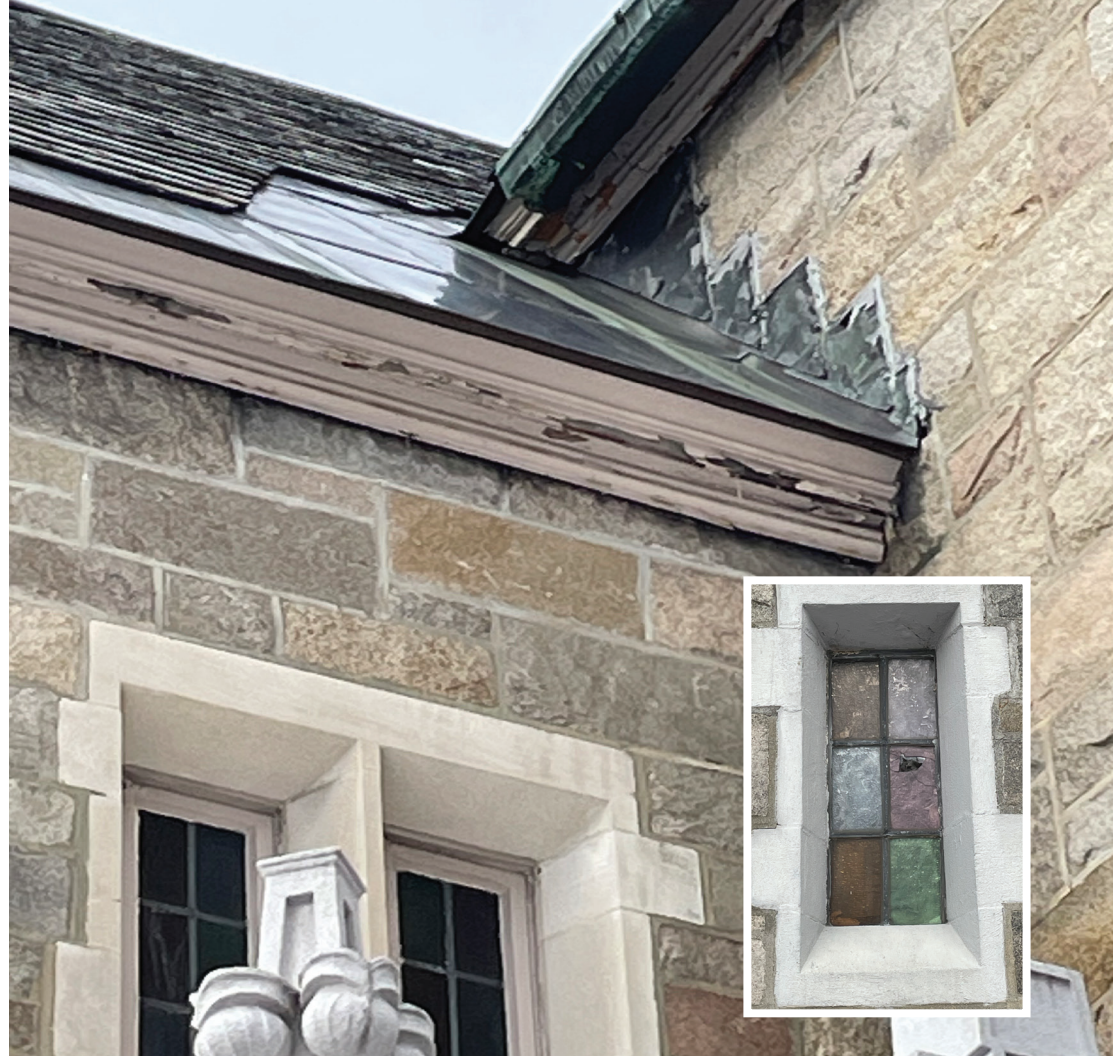
Exterior Church Restoration \$698,000

- Remove all existing latex coatings on limestone
- Rake out and repoint all “replacement” mortar and any missing mortar joints
- Repair damaged limestone
- Gable end capstones should be removed and reinstalled with through-wall flashing under the cap
- Remove/replace/reset all granite treads and railings at the entrances on the south building elevation
- Replace copper flat seamed roof on the east building elevation at the exit door
- Replace all damaged exit doors
- Replace/repair damaged slate shingles
- Reinstall missing gutter hangers
- Scrape, repair, prime and paint all exterior wooden trim
